ACO Stainless – System 100

Case Study

Harris Farm Markets, West End, QLD

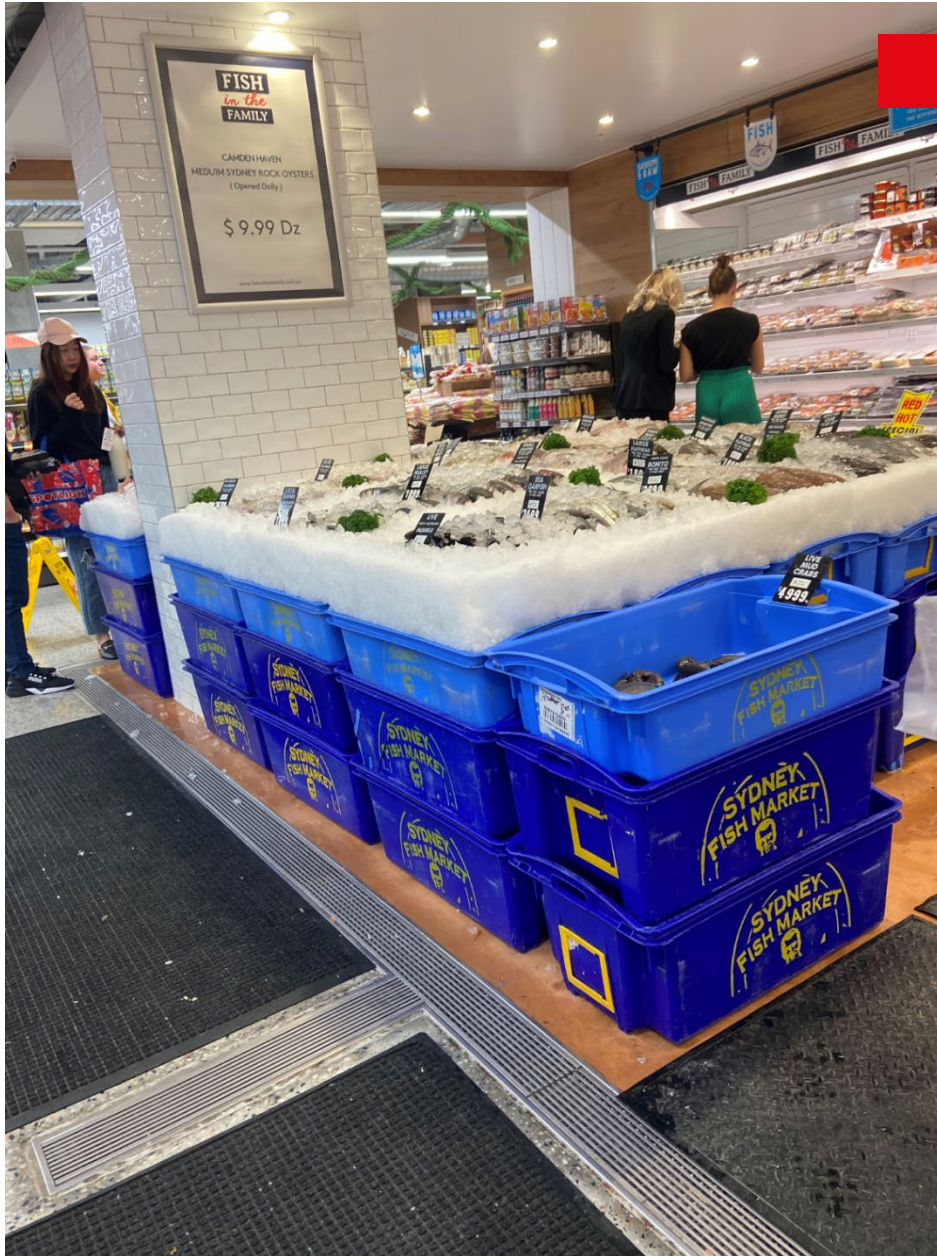
- **System 100** with Stainless Steel 5 Star **Heelsafe**® *Anti-Slip* grates

- The stainless steel channel has a 1:100 built in fall enabling efficient drainage to outlets
- The channel and grate system was fabricated from grade 304 stainless steel, to provide adequate corrosion resistance for cleaning chemicals
- The **Heelsafe**® *Anti-Slip* grate with 6mm slots and R11 slip resistance (AS 4586) ensures public safety even after washdown operations.
