ACO Stainless – System 300

Case Study

Simplot, Bathurst NSW

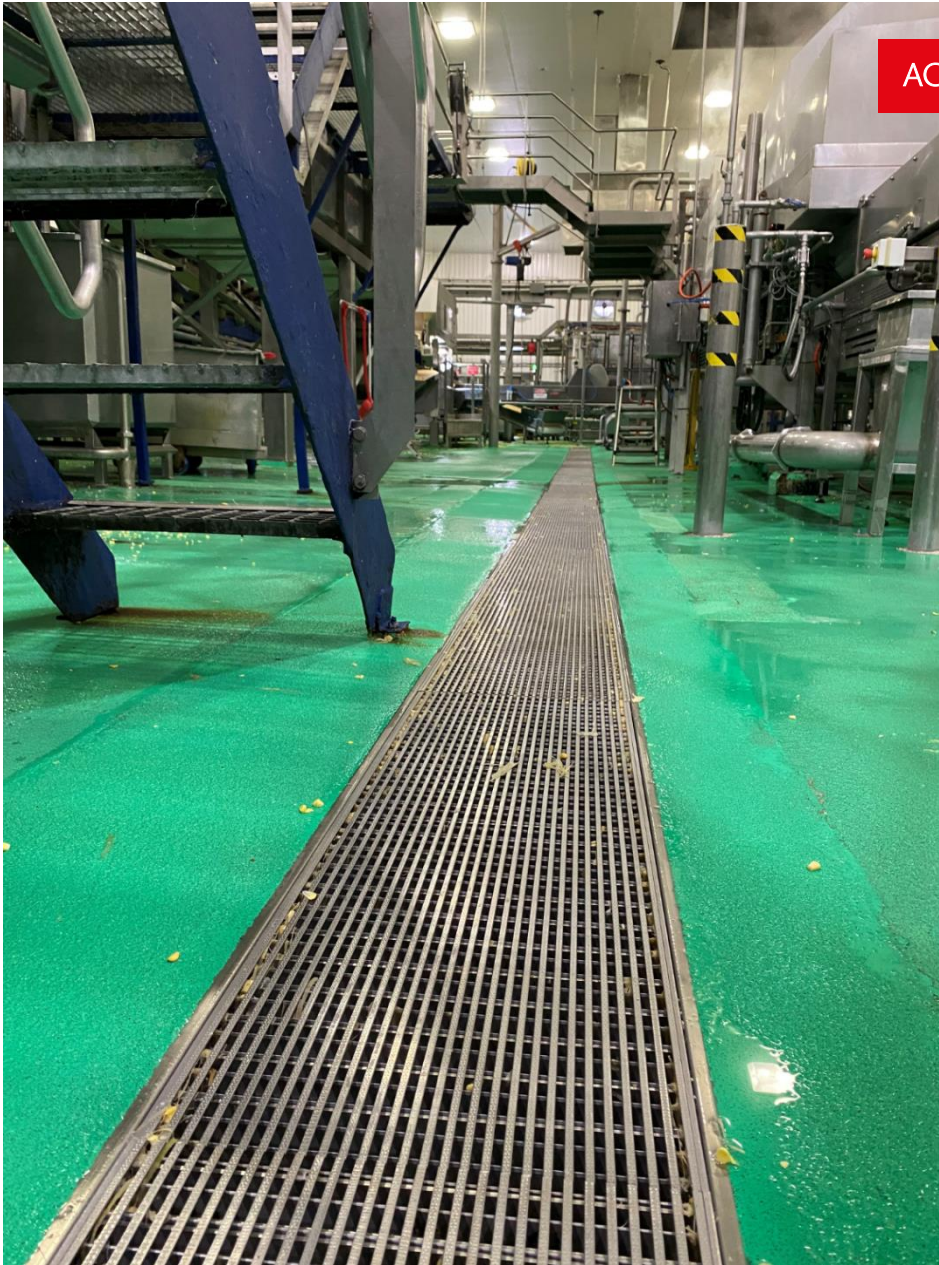
- **System 300** with Stainless 5 Star **Heelsafe**® *Anti-Slip* grates

- The stainless steel channel has a 1:100 built in fall enabling efficient drainage to outlets
- Stainless 5 Star **Heelsafe**® *Anti-Slip* with 7mm slots prevent the majority of food solids from entering the drainage system and creating blockages
- The channel and grate system was fabricated from grade 316 stainless steel, to provide a higher level of corrosion resistance for cleaning chemicals
