ACO Stainless – System 100

Case Study

Sash Western Sydney Animal Hospital, Prospect, NSW

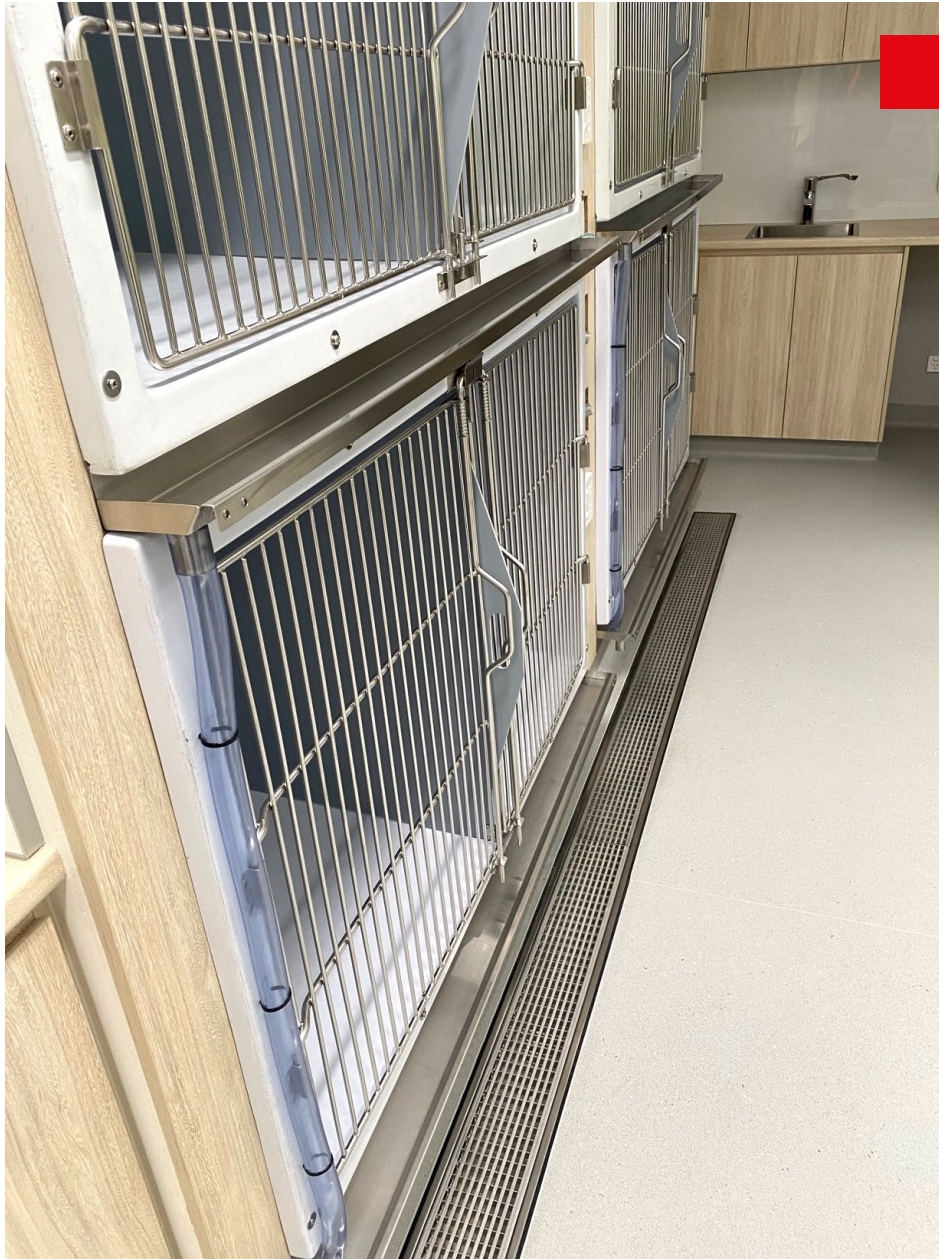
- **System 100** with Vinyl Seal Stainless Steel 5 Star **Heelsafe**® *Anti-Slip* grates.
- ACO worked with the builder to ensure the custom drain was sized correctly for the application.

- The stainless steel channel has a 1:100 built in fall enabling efficient drainage to outlets.
- The channel and grate system was fabricated from grade 304 stainless steel, to provide adequate corrosion resistance for cleaning chemicals.
- Vinyl Seal provides a superior seal between the drain and vinyl sheet flooring.
- The grate comprises 6mm slots and R11 slip resistance (AS 4586) to reduce slip hazards even after washdown operations.
